# Combined NDT inspection

Ultrasonic measurements and visual inspection of a carbon steel tank.

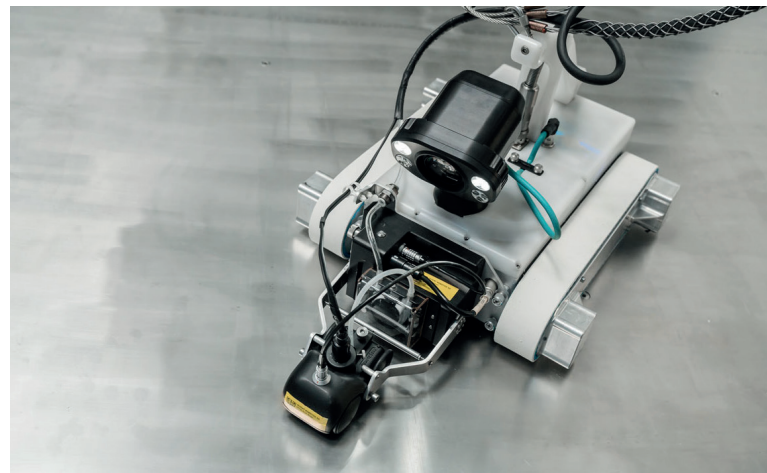
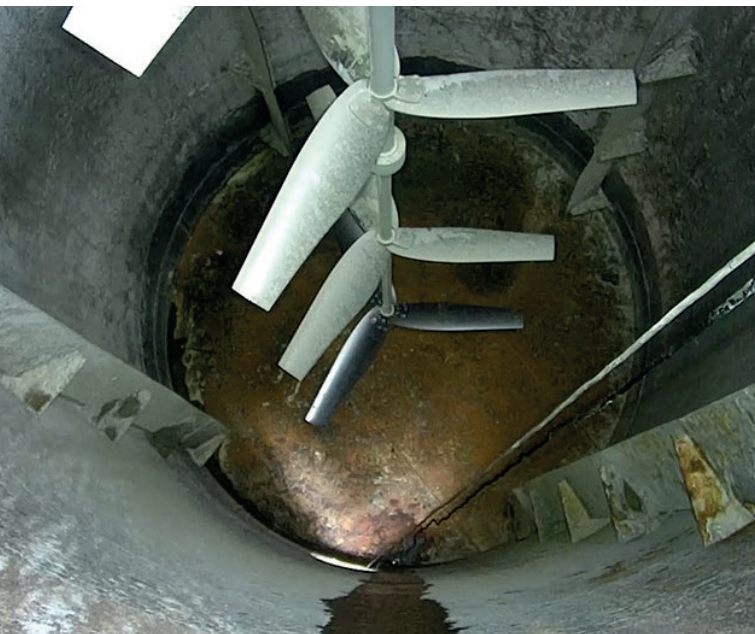
The heavily corroded surface combined with the inner layout including an agitator and baffles running up to the roof made inspection of this vessel challenging.

A custom ramp was built to ensure the robot could reach even the most difficult to reach areas of the slurry-tank. Utilizing the state-of-the-art camera and its 30x optical zoom function and an Olympus 38-DL UT-probe mounted in front of the robot as a buggy, Invert Robotics successfully inspected the slurry-tank using both required methods.
