Repair or replace? Visual inspection of a fifty-year-old spray-dryer

Utilising its high-definition camera system, Invert Robotics conducted a visual inspection of a stainless-steel spray dryer within a day, delivering a highly detailed inventory of the vessels' condition for the customer.

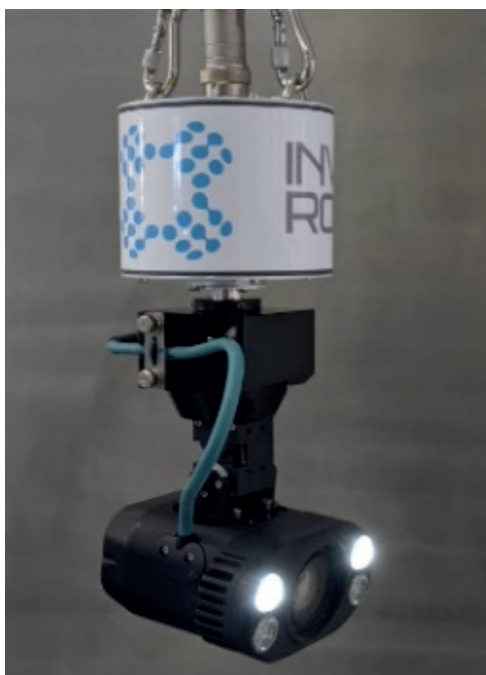
Instead, we took advantage of the capabilities of the high-definition camera used on our crawlers and mounted it on a very stable Remote Camera System, or RCS, mounting (see picture). Combining this

vertical control with the pan-and-tilt bracket and the 30x optical zoom of the camera, allowed us to inspect and map the entire vessel with a resolution of 0.015 mm.
