Using UT to inspect coal bin wear at a coal processing facility in Australia

In a collaborative project with a major Australian inspection services provider, Invert Robotics developed a custom M-serie robotic platform to take ultra-sonic wall thickness measurements without entering the confined space of a coal distribution hopper.

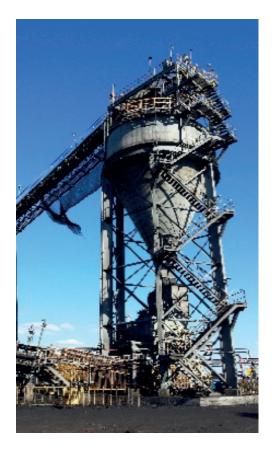
Invert Robotics' rapid response team designed a custom magnetic crawler capable of holding the required prototype UT payload, and capable of moving within the confines of the conical vessel.
